# ENGINEERING SUPPORT PROGRAM

EVALUATION OF PUL-E-KHUMRI I & PUL-E-KHUMRI II  
MINI-HYDROELECTRIC POWER PLANTS  
CITY OF PUL-E-KHUMRI,  
NORTHERN AFGHANISTAN

MAY 2, 2010

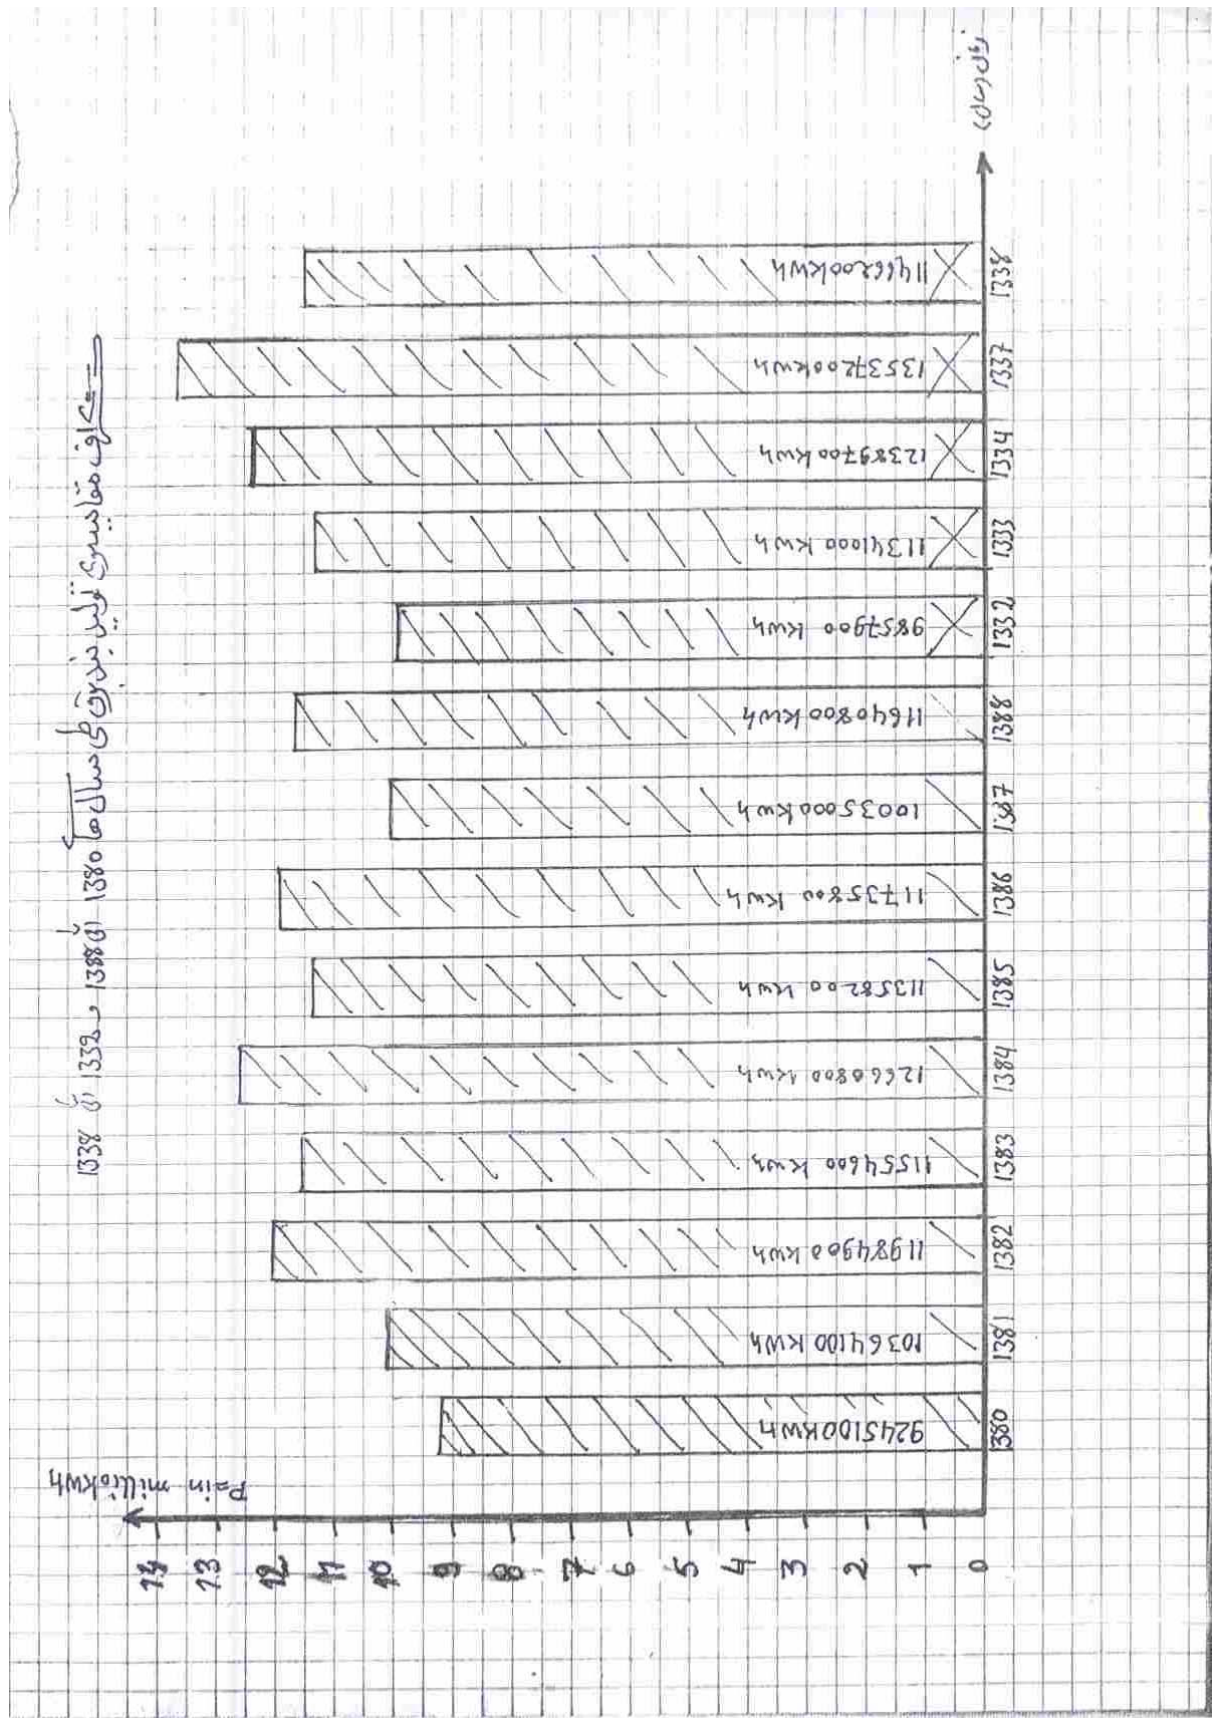
FIGURE 2 – TYPICAL PUL-E-KHUMRI I HYDRO PLANT OPERATIONS DATA RECORD SHEET (NOTED POWER GENERATION UNITS NOTED IN MEGAWATTS)

The Pul-e-Khumri I plant personnel could not produce hydrologic records (river flow or flow-duration data for the Baghlan River nor flow information for the power canal. Rather only records of the power generated (in Megawatts) by the hydro plant operations (an example data record sheet is shown on Figure 2). There is a staff gage located on one wall structure, however, apparently it is not routinely used for water stage monitoring purposes.

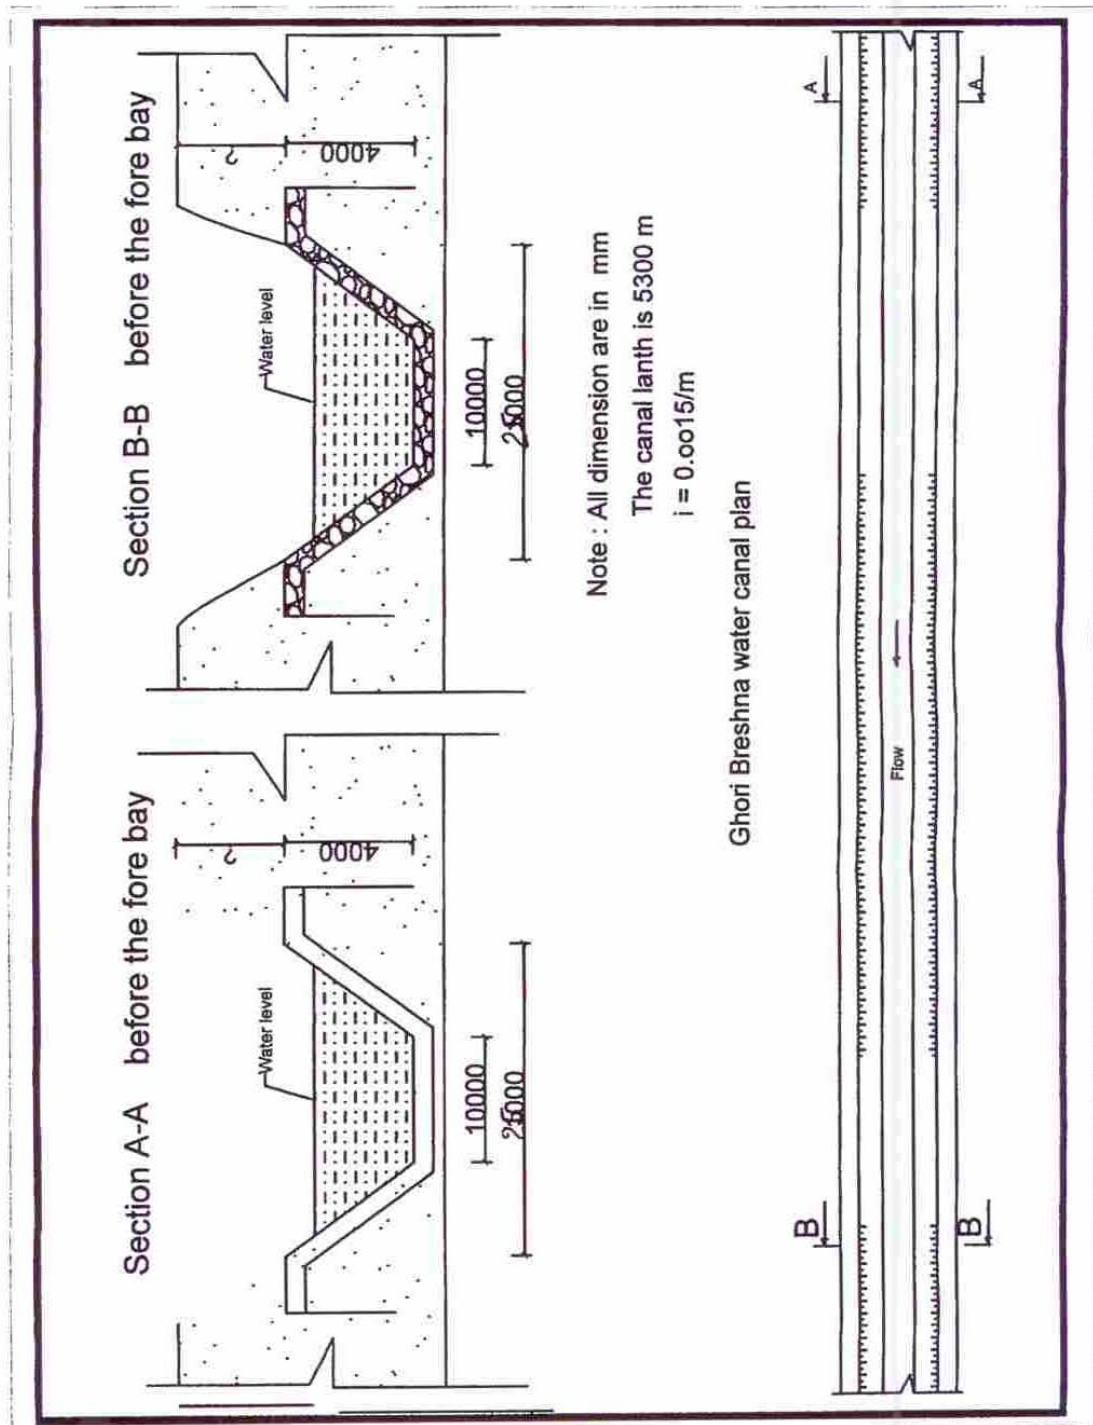
FIGURE 3 – TYPICAL GHORī BRESHNA WATER CANAL PLAN

Based on the dimensions shown on Figure 3 for the Ghorī Breshna Water Canal Plan and the USACE reporting above, the existing carrying capacity of the existing power canal system is on the order of 39 m<sup>3</sup> per second, which is roughly 70 percent less than the total carrying capacity of the canal system of 144 m<sup>3</sup> per second without the deposited sediment.

Dredging the canal of the sediments (upwards of an estimated 300,000 cubic meters and more) is the only solution to achieve the former total carrying capacity of the canal needed for restoring the original power generating capacity of the existing dam facility. A selected dump site for the dredged sediments from the canal is reported to be located in the Kar Kar area (the grid for the general dump area is 42SVE7684) and is located approximately 20 to 25 km away from the City of Pul-e-Khumri.

Also, as noted in the USACE report, unexploded ordnance (UXO) presents a real safety hazard for performing dredging activities in the power canal. Therefore, safety procedures for detecting and disposing with UXOs must be developed in advance of any future dredging work to be performed in the power canal.
